It's not a Ranger thing

By Clinton Brett, Diesel Help Australia

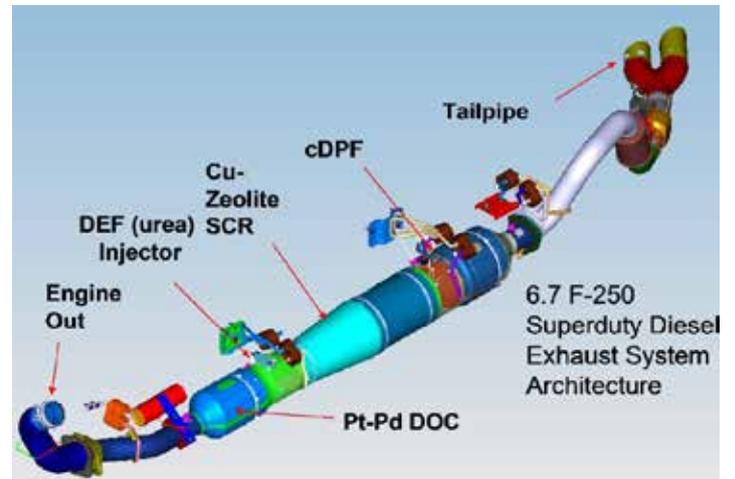
DEF Adblue V8

US technical information for the 2017 Ranger and F series fitted with the 6.7L V8. These incorporate the AdBlue/UREA which is also referred to as Diesel Exhaust Fluid (DEF). Who knows, we might see this AdBlue system fitted to the new Ranger V6 power stroke??

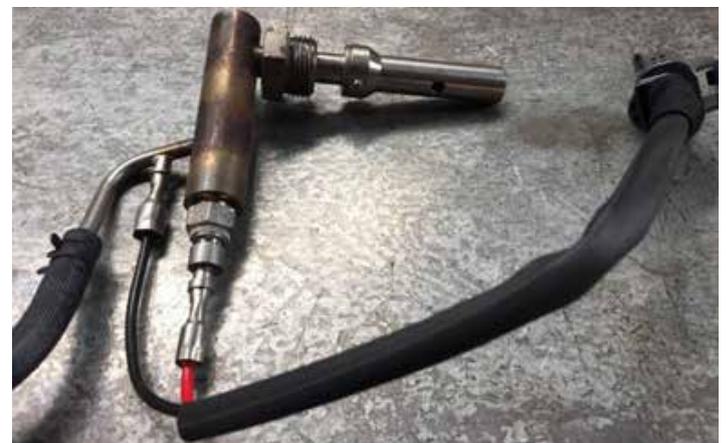
A common failure related to this P244C code found in the Ford applications in the past, has been a blocked vaporizer. The vaporizer is physically blocked, or a blown fuse due to a vaporizer component internal short circuit caused by the vaporizer glow plug overheating. This can occur in the BT50 but the most common failure we see is the Vaporizer pump failure.

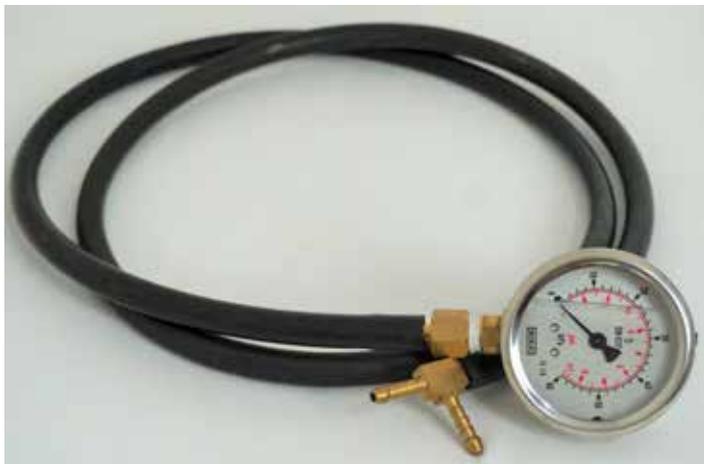
DPF Test Gauge & Hose

The DSI monitoring strategy includes circuit continuity checks for vaporizer pump and vaporizer glow plug, plausibility, check for vaporizer glow plug relay, and DSI leakage monitor. To begin diagnosis, first connect an analogue pressure gauge to the differential pressure sensor hose on the engine side to assist with confirmation the differential sensor is operating ok and the condition of the DPF- Is it blocked or not. By comparing to the scan tool, this will in turn confirm whether the DPF is blocked, and the differential sensor is working ok.

We recently released a DPF, Turbo Boost test kit to assist with testing DPFs. They were very popular, and the first batch was sold out before we could release them on the website. If you are interested in one of these tests or want to know more about them, send us a message <https://www.dieselhelp.com.au/contact/>

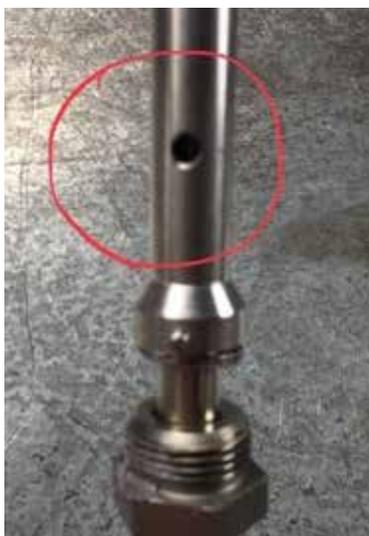
Location Of Blocked Vaporizer

Gain access to the vaporizer, connect a vacuum pump (Mityvac) and see if the vaporizer holds a vacuum. If so, then the vaporizer is blocked and will need replacing. If the results come back showing it is not blocked, it still may be restricted and therefore worth removing for final inspection. If the fuse for the vaporizer glow plug or pump has blown, then test the glow plug resistance (Nominal 1.1 Ohms, if less than 0.8 Ohms or greater than 1.3 Ohms then the vaporizer glow plug is faulty and will need to be replaced).

Solution: Remove and replace vaporizer, pump and glow plug as a complete system. Be sure to confirm the condition of the DPF before quoting. Remove and clean fuel hoses from the main fuel tank to the vaporizer pump. Relearn the system when if required.
